MISSE-6 Post-Flight Examination, Disassembly and Analysis Results

**Report submitted to Air Force Office of
Scientific Research
Contract FA9550-09-C-0206**

FINAL REPORT

Post Flight Inspection and Test Results for MISSE-6 Power Distribution System and Boeing Experiment Data Wiring.

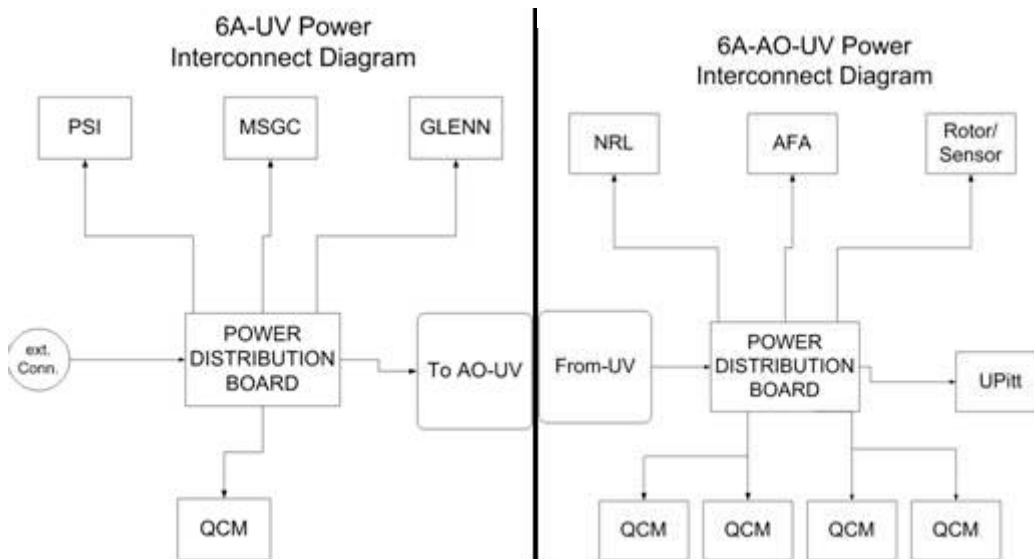
Figure A28: 6A power interconnect diagram

The MISSE-6A PEC power was fed to the 6A-UV tray via a MIL-C-38999 -41 shell connector. The receptacle mounted on the PEC was connected to via a special extra-vehicular activity plug (EVA plug) which brought power from the DC-DC power converter box. Internal wiring on 6A connected the 38999 receptacle to the terminal blocks on the power distribution board. Each terminal on the UV side connected 2 wires, one wire from external connector, one wire going to a cable that crossed from the UV tray to the AOUV tray and into the terminal blocks on the AOUV side. Note that in Figure A28 below the blocks labeled “To AO-UV” and “From-UV” represent the interconnecting cable bringing power from the UV side to the AOUV side.

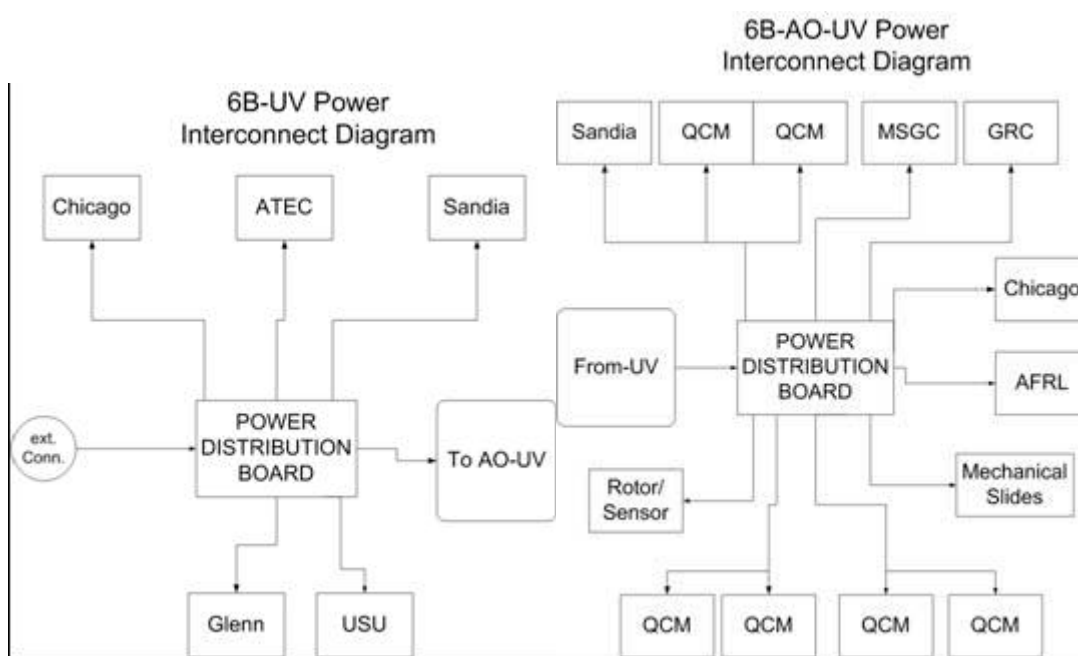
Figure A35: 6B power interconnect diagram

The MISSE-6B PEC power was fed in via the same method as 6A, a MIL-C-38999 -41 shell connector with an EVA plug bringing in power from an external power LRU. Internal wiring on 6B was also similar. Note that in Figure A35 below the blocks labeled “To AO-UV” and “From-UV” represent the interconnecting cable bringing power from the UV side to the AO-UV side.

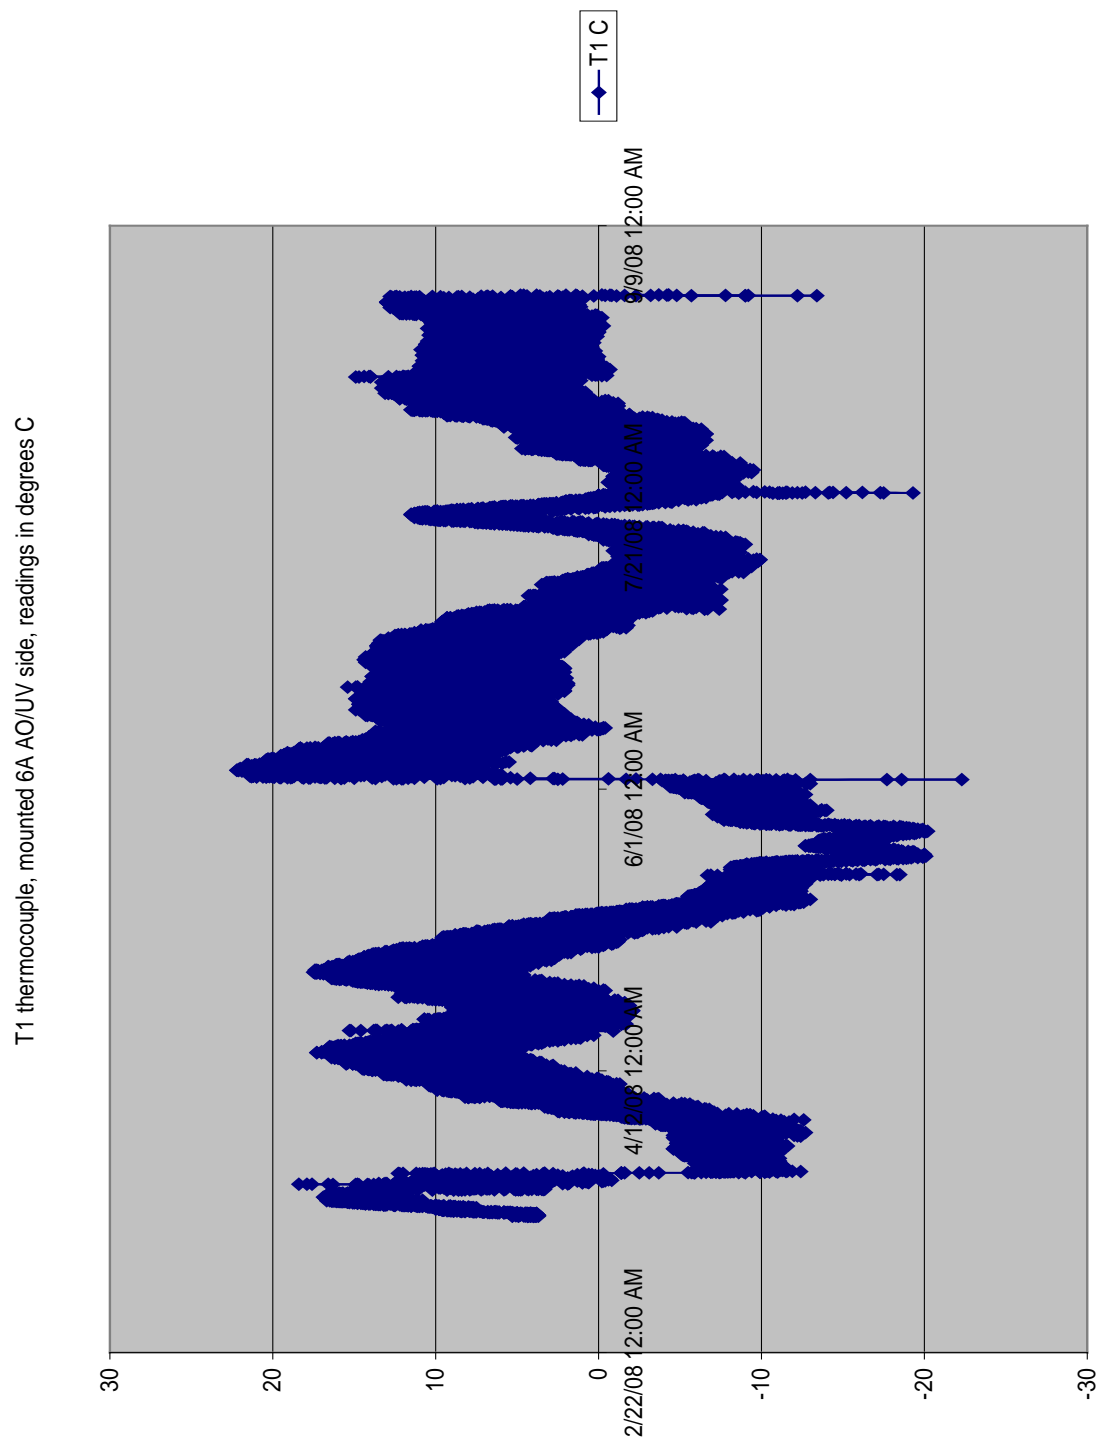
The circuit boards for the Q9 and Q10 quartz crystal microbalance boards were labeled backwards. The large mechanical shutter experienced a rotation failure due to mechanical binding of the shutter in contact with the motor housing. Wires for specimen sets P1 and P2 on the University of Pittsburgh experiment lacked a data ground. The data lines to dataloggers D1 and D7 were loose. Thermocouple T1 was disbonded.

Figure B1 Time-Temperature profile for Thermocouple at T1.
